LANDSCAPE ARCHITECTS
Morrow Reardon Wilkinson Miller, Ltd.

TRUTH OR CONSEQUENCES NEW MEXICO

SITE ANALYSIS

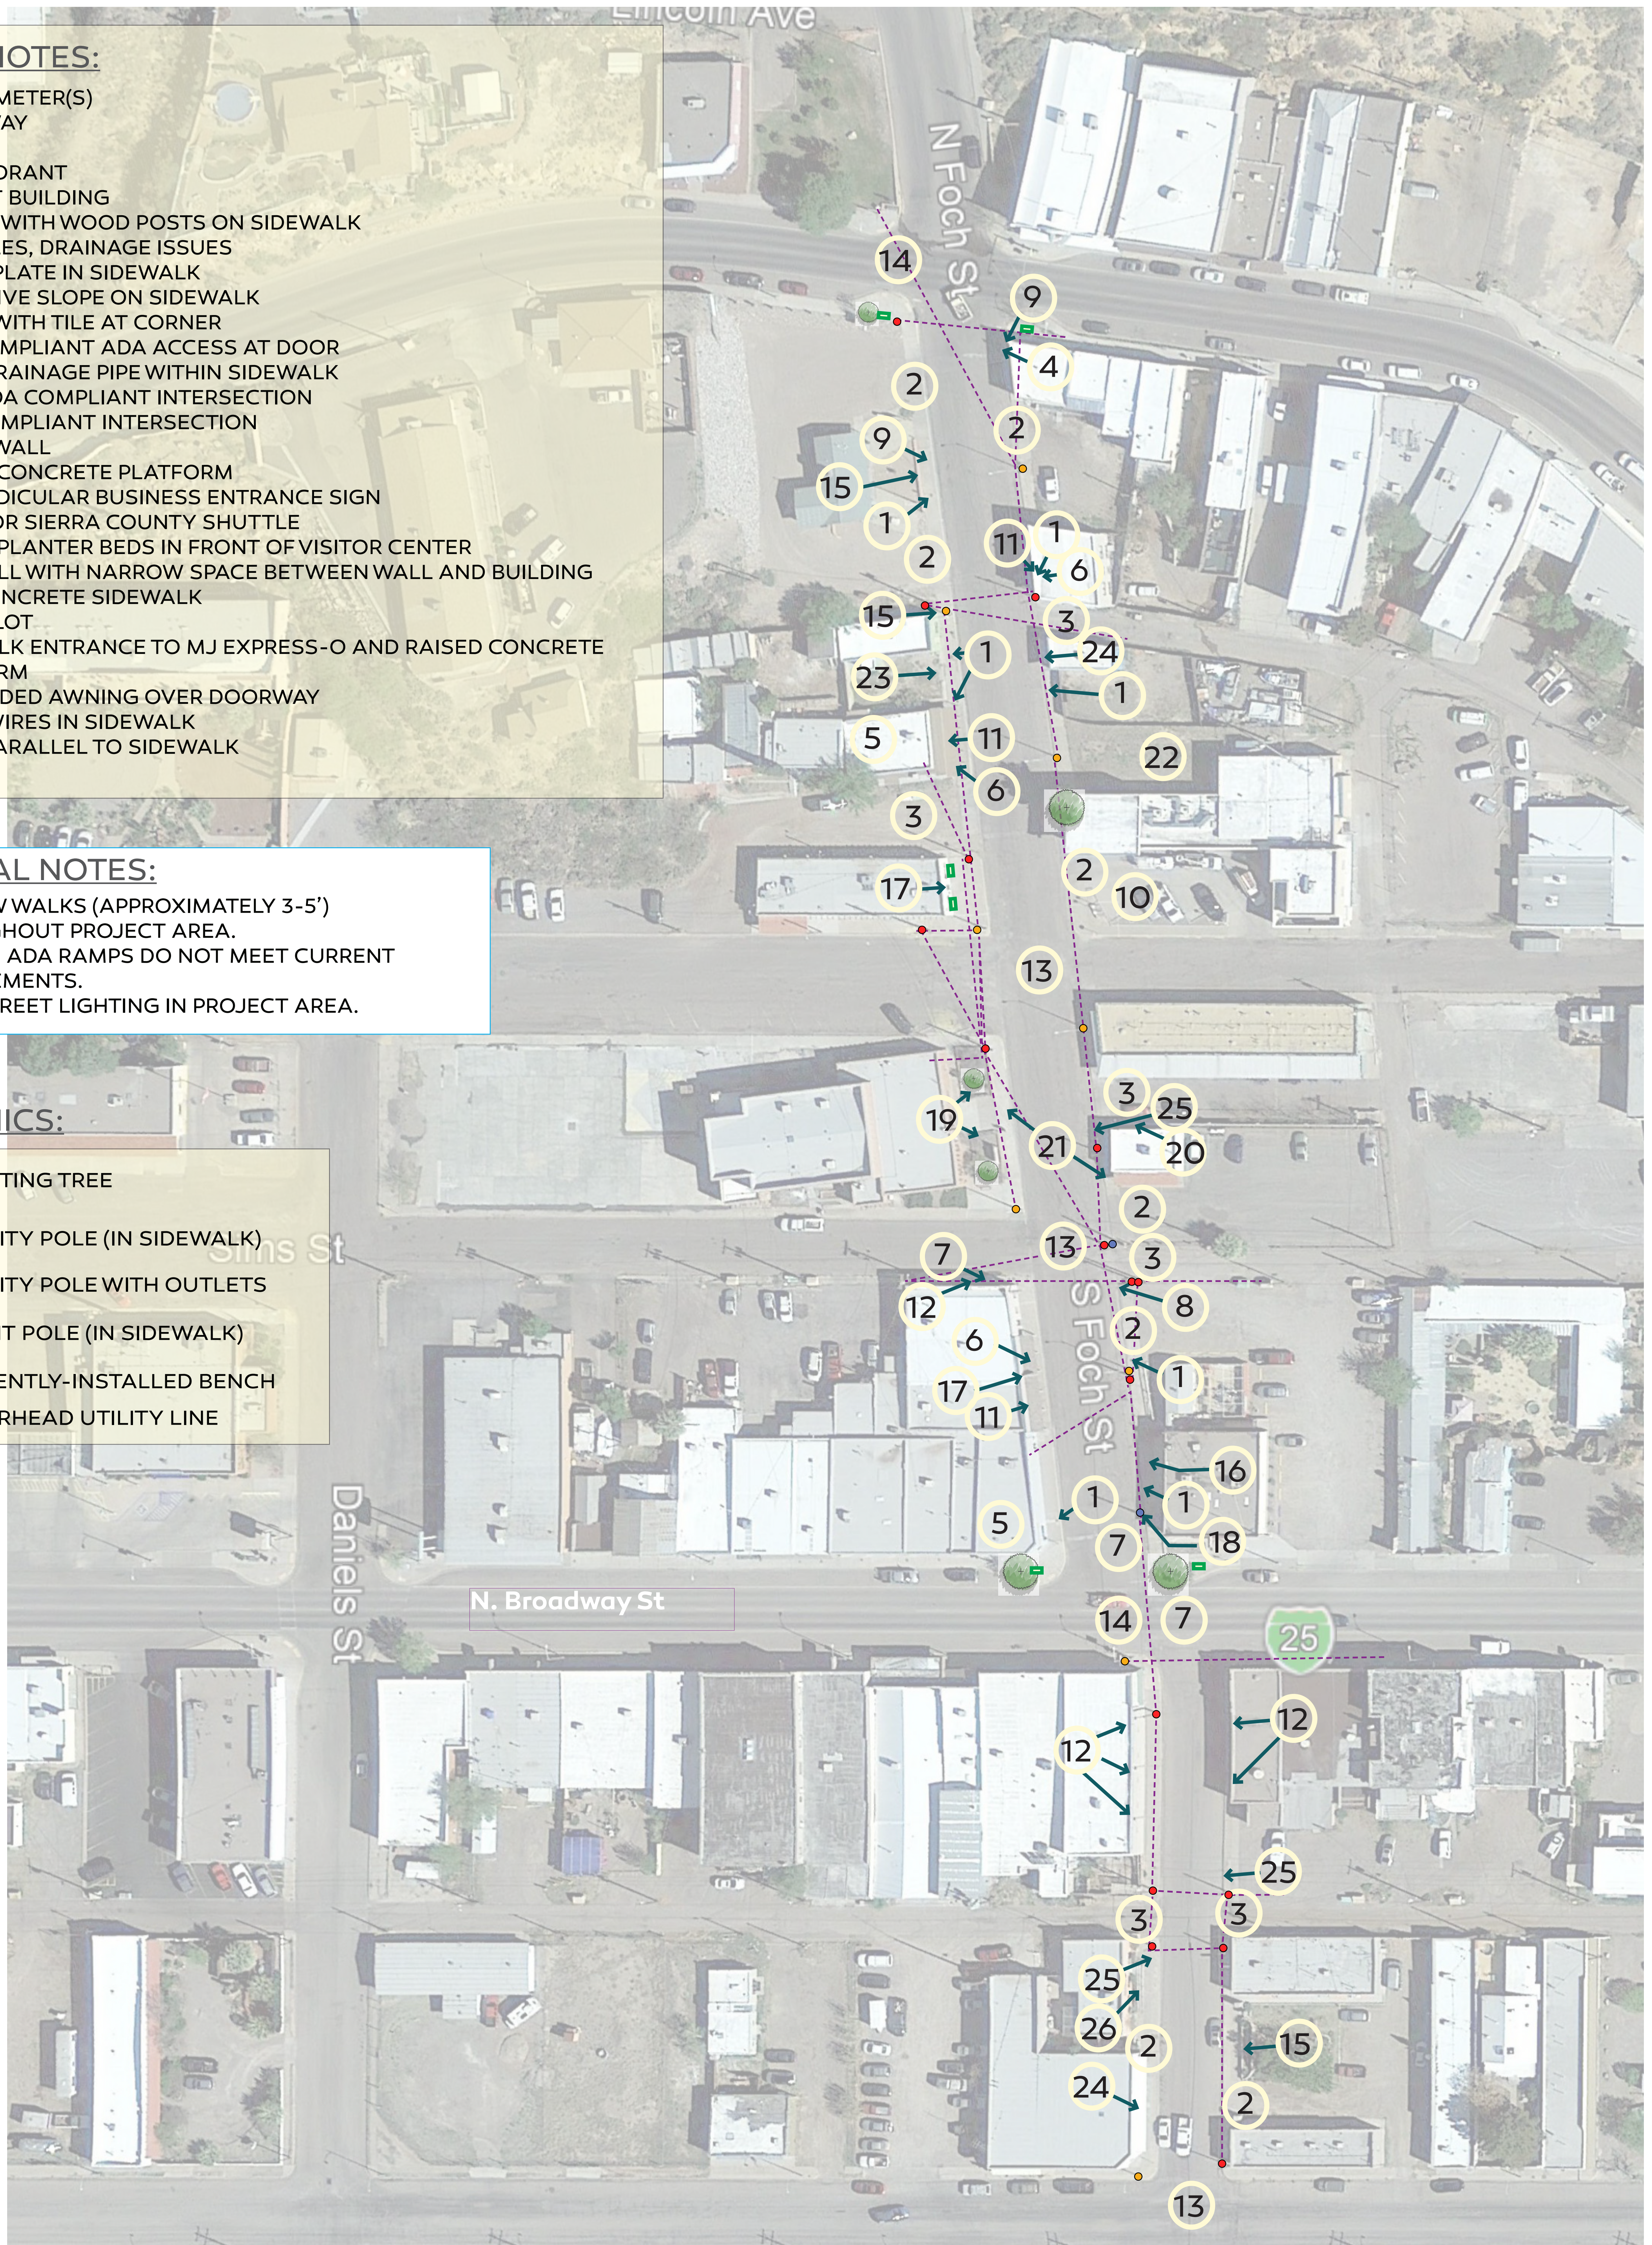
1. WATER METER(S)
2. DRIVE WAY
3. ALLEY
4. FIRE HYDRANT
5. VACANT BUILDING
6. PORTAL WITH WOOD POSTS ON SIDEWALK
7. POTHOLES, DRAINAGE ISSUES
8. METAL PLATE IN SIDEWALK
9. EXCESSIVE SLOPE ON SIDEWALK
10. BENCH WITH TILE AT CORNER
11. NON COMPLIANT ADA ACCESS AT DOOR
12. ROOF DRAINAGE PIPE WITHIN SIDEWALK
13. NON-ADA COMPLIANT INTERSECTION
14. ADA-COMPLIANT INTERSECTION
15. SHORT WALL
16. RAISED CONCRETE PLATFORM
17. PERPENDICULAR BUSINESS ENTRANCE SIGN
18. STOP FOR SIERRA COUNTY SHUTTLE
19. RAISED PLANTER BEDS IN FRONT OF VISITOR CENTER
20. 6 FT WALL WITH NARROW SPACE BETWEEN WALL AND BUILDING
21. NEW CONCRETE SIDEWALK
22. EMPTY LOT
23. SIDEWALK ENTRANCE TO MJ EXPRESS-O AND RAISED CONCRETE PLATFORM
24. SUSPENDED AWNING OVER DOORWAY
25. GUIDE WIRES IN SIDEWALK
26. RAMP PARALLEL TO SIDEWALK

- NARROW WALKS (APPROXIMATELY 3-5') THROUGHOUT PROJECT AREA.
- CERTAIN ADA RAMPS DO NOT MEET CURRENT REQUIREMENTS.
- ONLY STREET LIGHTING IN PROJECT AREA.
